Safety Recall 5923F – 2024 CX-90 Suspension and Steering Insufficient Bolt Torque**A. VEHICLE INSPECTION PROCEDURE – AND PREPERATION FOR REPAIR**

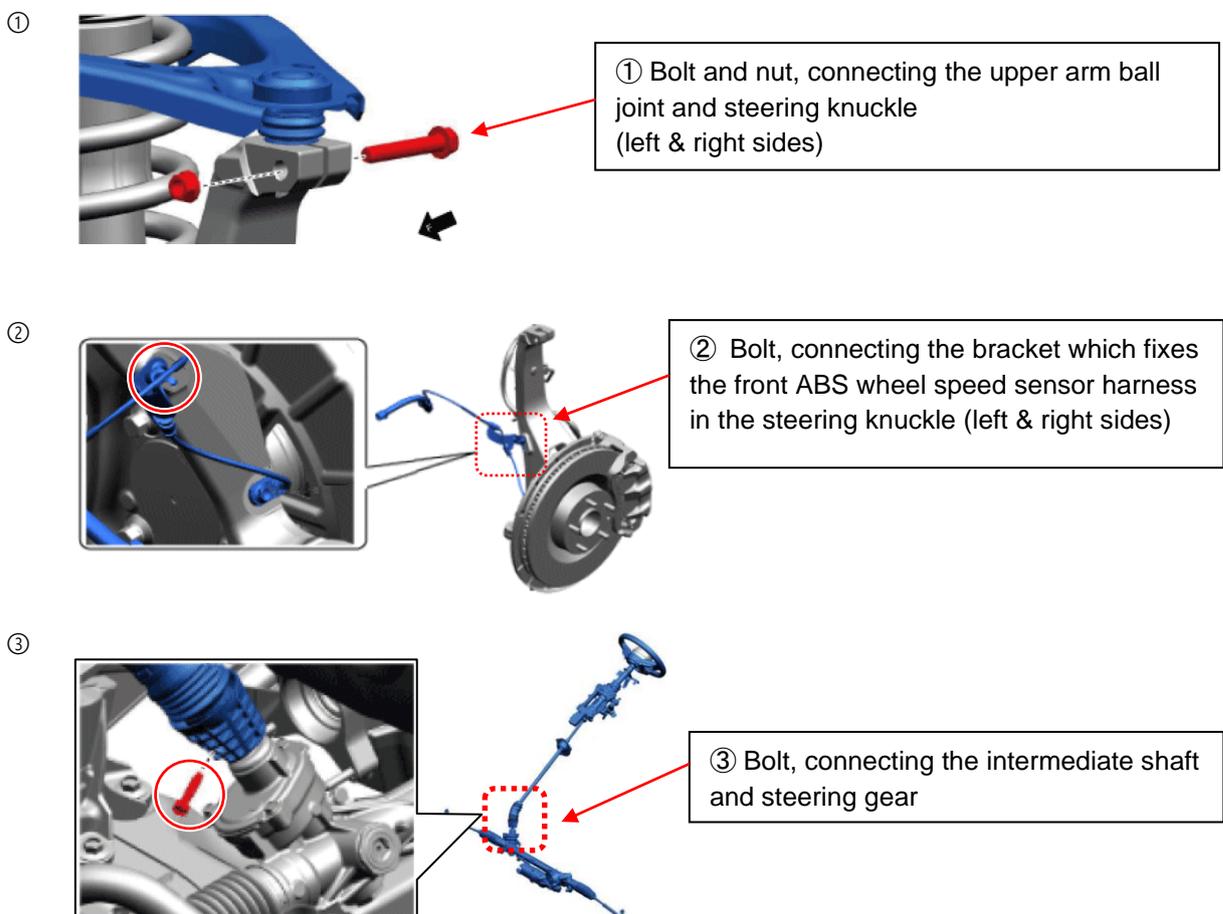
Potentially affected bolts:

- Check the fastening torques of all bolts ① to ③ in the figures above (at 5 portions), and ensure all bolts are torqued to proper specification.
- If any bolts or nuts are missing at time of inspection, install new parts and torque them to proper specification.

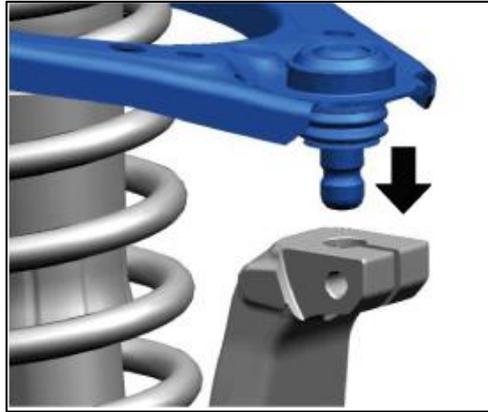
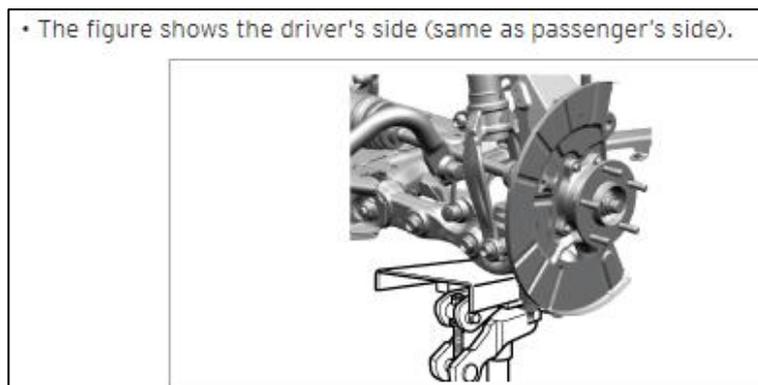
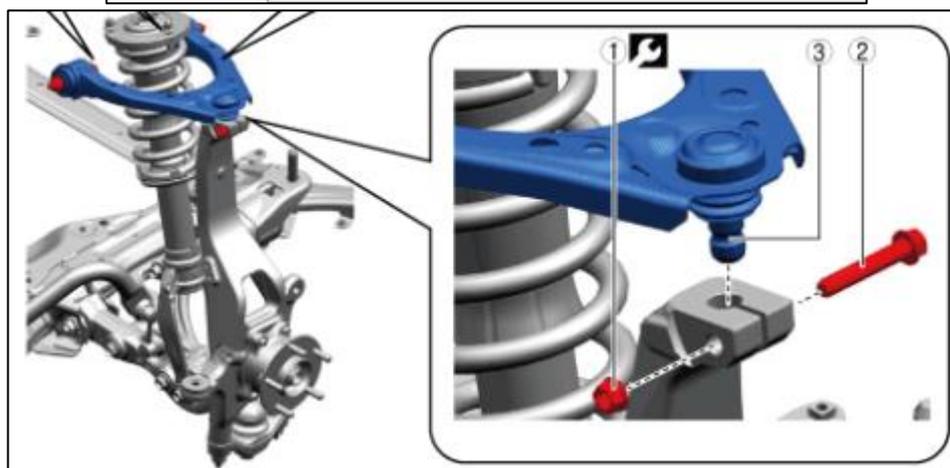
NOTE: If the ball joint was not fully inserted or the bolt is loose, place a jack under the lower control arm to load the suspension and ensure that the upper control arm ball joint is fully inserted before tightening.

- A) Inspect and Tighten the LH and RH Front Upper Control Arm Ball Joint Bolt to Steering Knuckle and ensure the ball joint is fully inserted into the Steering Knuckle
- a. Torque the Bolt to 42.5 N·m {4.3 kgf·m, 31.15 ft·lbf}
- The figure shows the driver's side (same as passenger's side)

Replace any missing bolts or nuts
